**DES MOINES SOUTH POND/
DRAINAGE AREA
SOURCE CONTROL OPERABLE UNIT
(OPERABLE UNIT NO. 4)
BUILDING SAMPLING, ANALYSES,
AND ENGINEERING EVALUATION
REPORT**

**DICO INC.
200 Southwest 16th Street
Des Moines, Iowa 50305**

ECKENFELDER INC.

August 1992

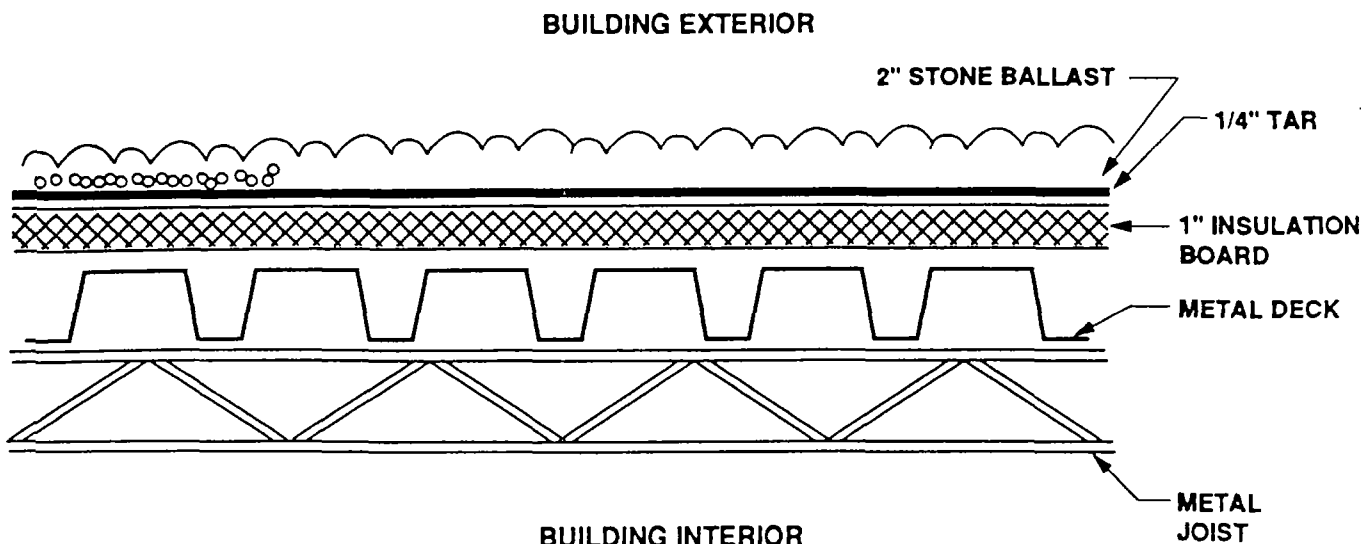
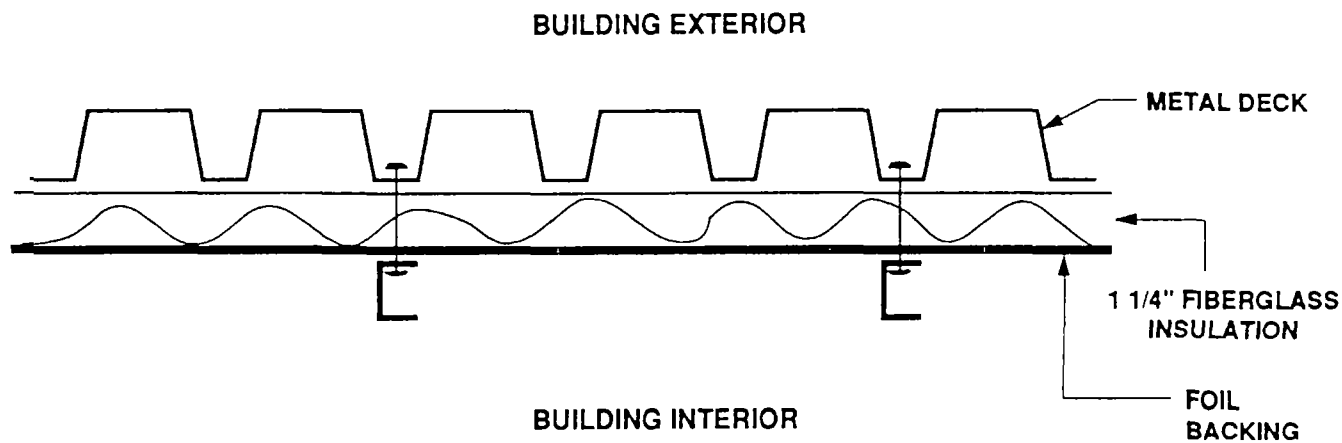
DICO INC. DES MOINES, IOWA	
FIGURE 3-1 TYPICAL ROOF SECTIONS BUILDINGS 1, 2, AND 3	
6836	3/92
ECKENFELDER INC.	Nashville, Tennessee Mahwah, New Jersey Rochester, New York

During the investigations, insulation samples established the presence of PCBs in ceiling insulation in Buildings 2 through 5 and the Maintenance Building as well as in wall insulation in Buildings 3, 4, and 5. Insulation in the ceilings of the buildings was installed as part of the roof system. In Buildings 2, 3, 4, and 5, the foil/fabric lined ceiling insulation is sandwiched between the roof joists and the metal roof deck which is located above the insulation. Buildings 4 and 5 contain two roofs. In the Maintenance Building the ceiling insulation is sandwiched between the roof deck and a metal liner panel in the shop areas. A suspended ceiling separates the roof area in the office area of the Maintenance Building. Figures 3-1, 3-2, and 3-3 show typical roof sections associated with the various buildings. Wall insulation in these buildings is, for the most part, attached to columns and siding girts and is part of the building structure. Wall insulation in portions of some of the buildings and in all of the Maintenance Building is covered by a metal liner panel.

**TYPICAL ROOF SECTION -
BUILDING 1**

**TYPICAL ROOF SECTION -
BUILDINGS 2 AND 3**

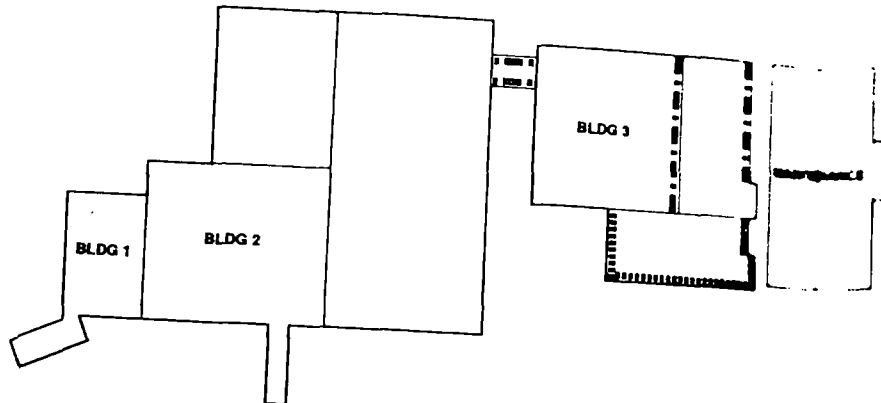
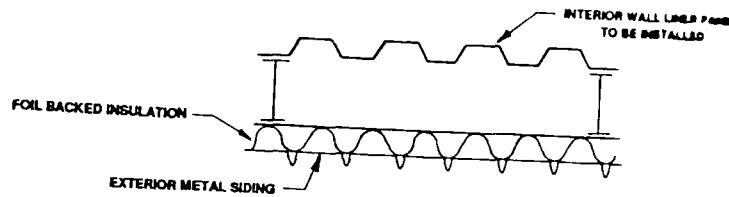
TOP VIEW OF TYPICAL
WALL LINER PANEL SECTION

Wall insulation extends from floor to ceiling in some areas, and partially covers walls in other areas. Wall insulation would be covered with thin sheet metal panels. Minor electrical and mechanical equipment relocations would be required to
